August 8, 2018
Yamaha Motor Co., Ltd.

Supplement to “3. If, as a result of the investigation, cases of fraud, etc. have been discovered”

1. Background

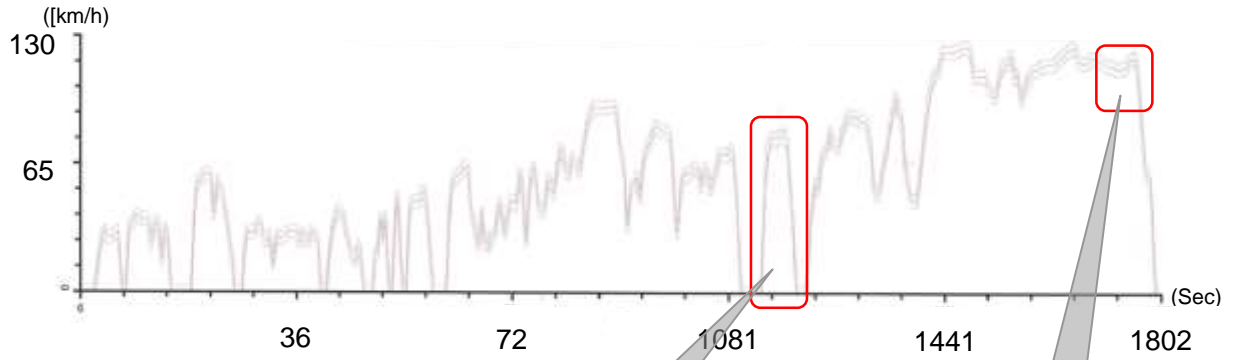
(Conditions of speed and time defined in WMTC mode)

Deviated from the test conditions for about 5 to 6 seconds when rapidly accelerating from an idling state to around 80km/h.

(1) (2) (3) (4)

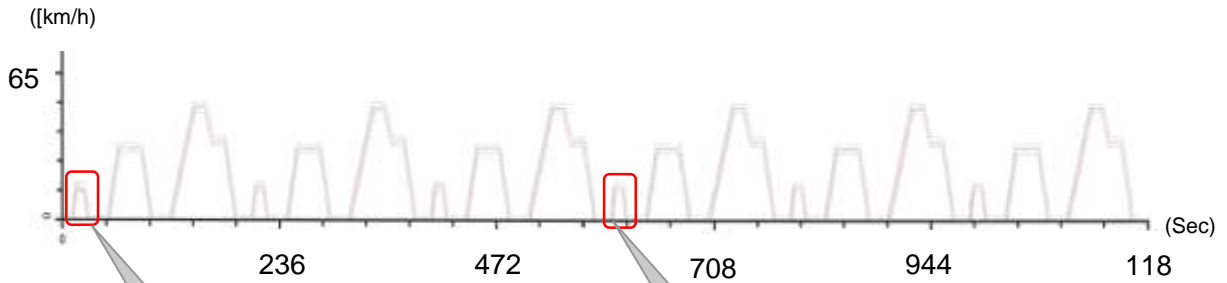
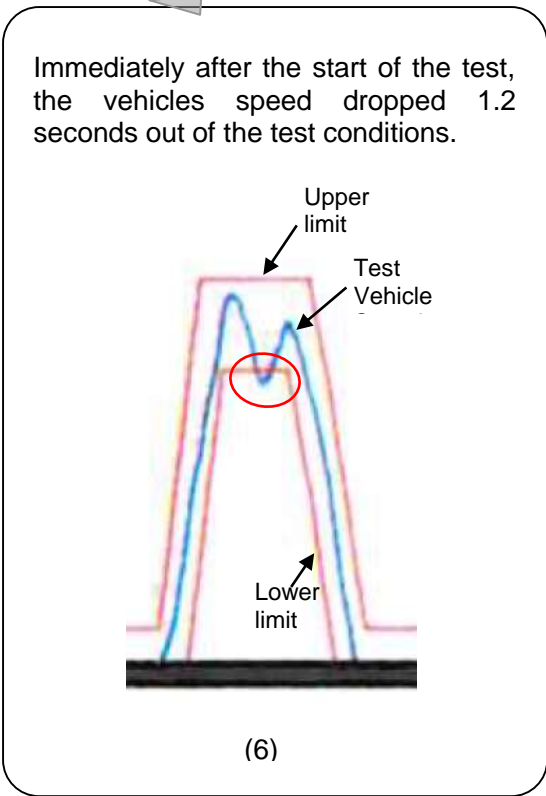
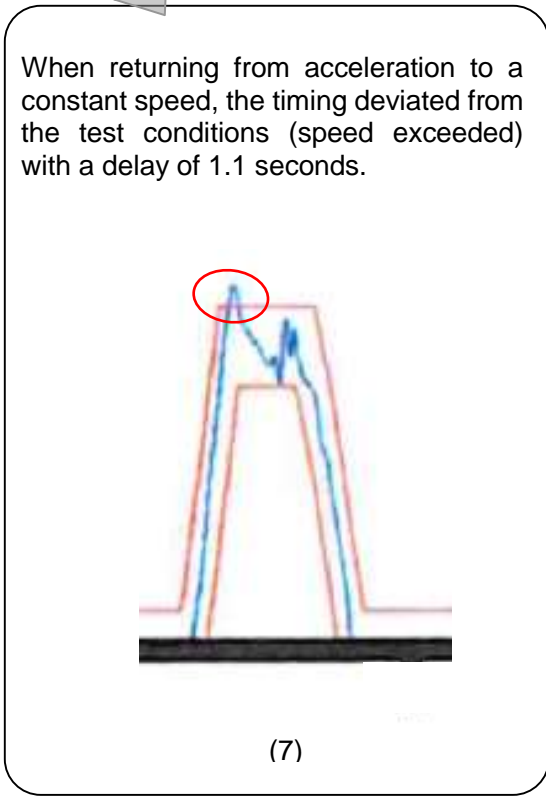
(Conditions of speed and time defined in Motorcycle mode)

The speed declined before the final deceleration, deviating from the test condition for 4.3 seconds.

(5)
