Inspection line of electronic components

Yamaha's answer to the user's needs.

Use of LCMR200 traversing unit makes it possible to perform the inspection on the line.

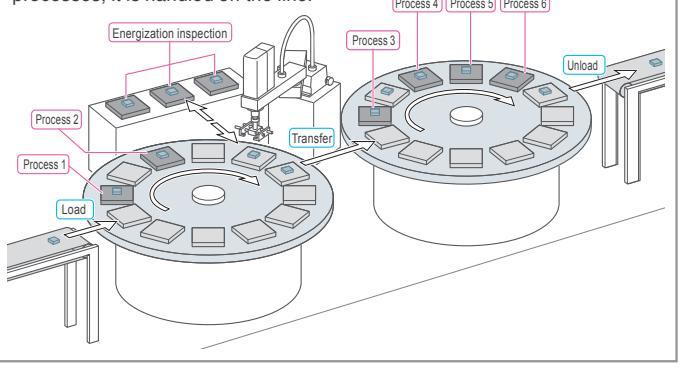
- Some inspection processes take time and cannot be completed in time without performing the inspections off the line.
 - → However, repeated line-off to the inspection processes may lead to quality deterioration. (Scratches or particles may occur during transfer.)
- Current index table is small and only one workpiece can be placed on one pallet.

In the energization inspection process, it is necessary to confirm the electrical conduction. So, this process takes more time than other inspection processes, it is handled off the line.

Offline process that takes a time becomes a bottleneck.

- It was considered to increase the size of the index table so that multiple workpieces could be placed on one pallet, but this idea was abandoned because the index table was difficult to adjust.
- Even if the index table can be adjusted to place multiple workpieces, workpieces need to be transferred to the inspection process that is off the line, and quality problems cannot be resolved.

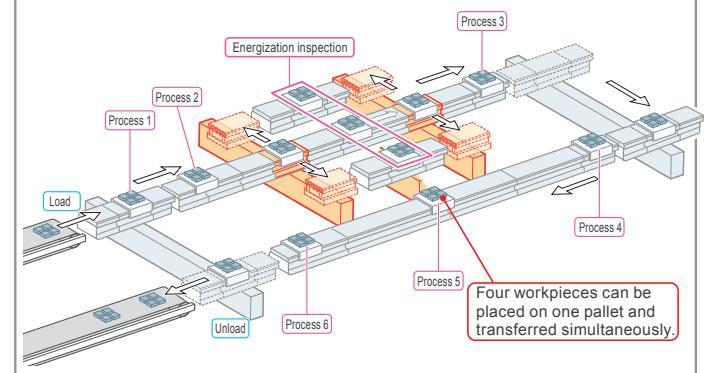
- Inspection process can be divided by the traversing unit.
- There is no need to transfer off the line for inspection, eliminating quality problems caused by scratches and particles.
- Multiple workpieces can be placed on a tray, achieving increase in production volume.

Inspection line of electronic components

Line can be branched by the traversing unit and the energization confirmation that takes a time can be performed on the line.

We went to an exhibition to find a good idea. When we stopped by the Yamaha booth, we found the LCMR200 traversing unit. By adopting the LCMR200 traversing unit, three branches allow inspection on the line, so there is no need to perform the inspection off the line as before.

In addition, we find that the high-speed transfer reduces the cycle time and enables simultaneous transfer and inspection of four workpieces, making it possible to achieve the target production volume only on the day shift.

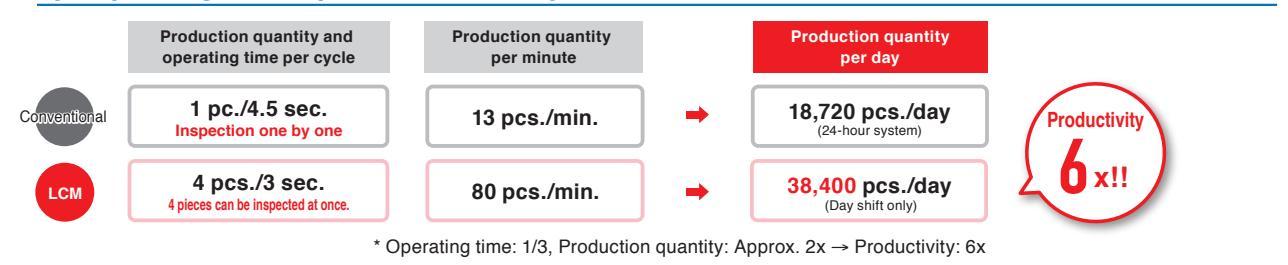
Increase in production quantity and decrease in defect rate are achieved at the same time by improving the inspection efficiency!
