# Friction Measurement of Al-17%Si Monolithic Cylinder with using Newly Developed Floating Liner Device

Tatsuhiko Sato Hiroataka Kurita Akemi Ito Hideyuki Iwasaki

当論文は、SAE 2014-32-0052 / JSAE 20149052として、Pisa(イタリア)で行なわれたSETC2014( Small Engine Technology Conference)にて発表され、Ten Best Paper Awardを得たものです。

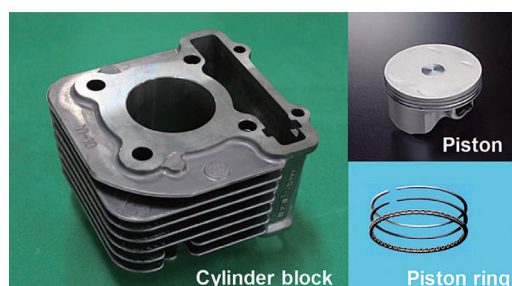
Figure 6: Appearance of tested components, cylinder block, piston and piston rings.

The appearance of tested cylinder block, piston and piston rings are shown in Figure 6. The cylinder block is made of hypereutectic Al-17%Si alloy by using a high pressure die casting process<sup>[6]</sup>. The chemical composition of the cylinder block is shown in Table 3. After die casting, the cylinder block was T5 heat treated. Then the cylinder bore surface was honed subsequently etched with alkaline solution in order to expose Si particles dispersed in an Al matrix. The surface morphology of alkaline etched surface is shown in Figure 7. These exposed Si particles play a role for preventing a wear and/or a scuffing phenomenon<sup>[10,11]</sup>.
